WAIKOLOA RESERVOIR NO. 1 EARTHQUAKE REPAIR PROJECT **Information Sheet**

The purpose of this Project is to repair damages to the Waikoloa Reservoir No. 1 which were sustained during the October 2006 Kīholo Bay Earthquake. After the Earthquake, an inspection of the Reservoir and its neighboring Reservoir – Waikoloa Reservoir No. 2 - found cracks in the internal slope, as well as seepage along the external embankment slope of both Reservoirs, requiring complete drainage of Reservoir No. 2 until the repairs were completed in 2011. While the repairs were being done, Waikoloa Reservoir No. 1 remained in service to maximize water storage for area residents. The Waikoloa Reservoir No. 1 Repair Project will involve installing a new liner on the floor and internal slope as well as stabilizing the external slope of the reservoir. Monetary funds for the Repair Project will be provided by the DWS. The DWS is presently seeking Federal Emergency Management Agency (FEMA) financial assistance for the Project construction.

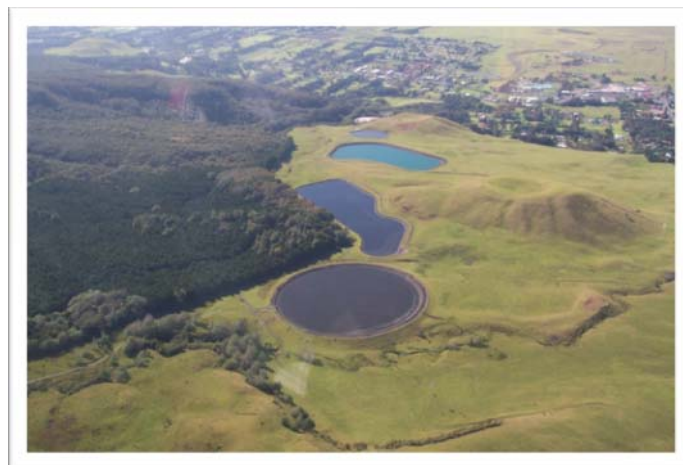
Figure 1: Waikoloa Reservoir No. 1 is the kidney shaped reservoir in the middle of the picture. Reservoir No. 2 is at the bottom and No. 3 is at the top. At the very top is the much smaller pentagon-shape 8.5-MG reservoir.

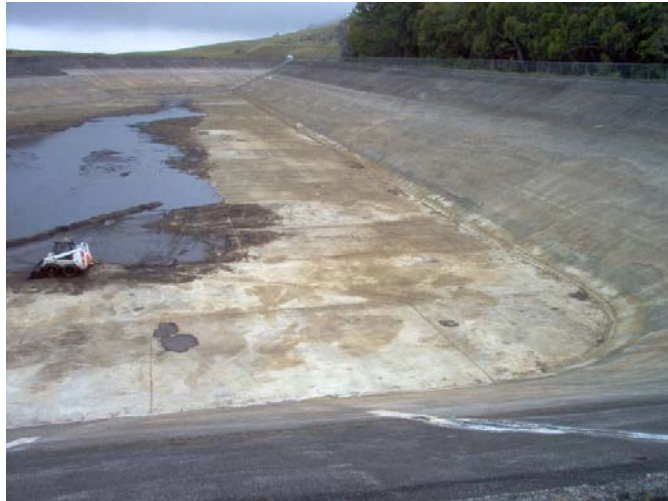
Figure 2: Waikoloa Reservoir No. 1 was partially drained after the 2006 Kiholo Bay Earthquake. It is presently empty and will remain empty until repairs are completed.

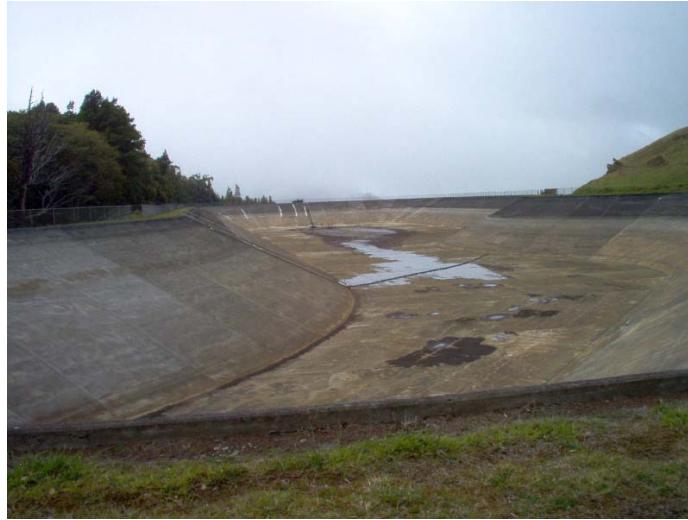
Figure 3: Due to an accumulation of sediment, the reservoir had to be scraped and washed.
