Emergency Action Plan (EAP) for WAIKOLOA RESERVOIR NO. 3

State ID # HA-0136

Hawaii, Hawaii

Emergency Action Plan (EAP)

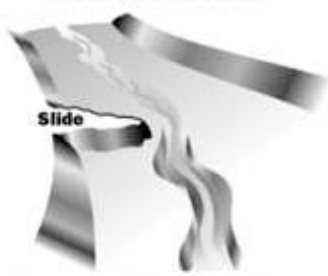
Excessive Vegetation or Debris in Channel	<p>Accumulation of slide materials, dead trees, excessive vegetative growth, etc., in spillway channel.</p> <p>Reduced discharge capacity; overflow of spillway, overcropping of dam. Prolonged overtopping can cause failure of the dam.</p>	<p>Clean out debris periodically; control vegetative growth in spillway channel. Install log boom in front of spillway entrance to intercept debris.</p>
Erosion Channels	<p>Surface runoff from intense rainstorms or flow from spillway carries surface material down the slope, resulting in continuous troughs. Livestock traffic creates gullies where flow concentrates varies.</p> <p>Unabated erosion can lead to slides, slumps or slips which can result in reduced spillway capacity. Inadequate spillway capacity can lead to embankment overtopping and result in dam failure.</p>	<p>Photograph condition. Repair damaged areas by replacing eroded material with compacted fill. Protect areas against future erosion by installing suitable rock riprap. Re-vegetate area if appropriate. Bring condition to the attention of the engineer during next inspection.</p>
